Docket No. 217 – Development and Management Plan Inspection

Northeast Utilities Service Company Certificate of Environmental Compatibility and Public Need for the construction of a 345-kV electric transmission line and reconstruction of an existing 115-kV electric transmission line between Connecticut Light and Power Company's Plumtree Substation in Bethel, through the towns of Redding, Weston, and Wilton, and to the Norwalk Substation in Norwalk, Connecticut.

Date: July 5, 2006

Location: 115 kV Underground Route

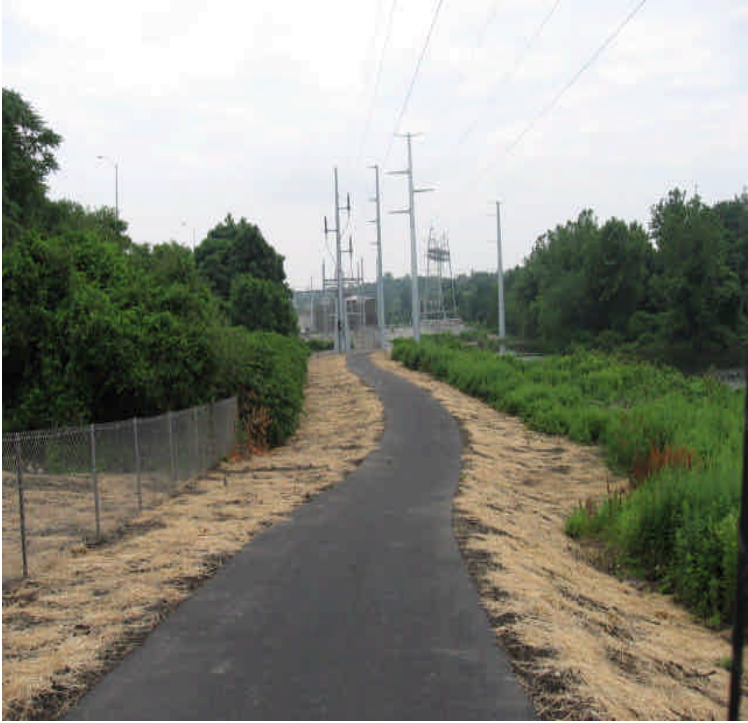
Photo on the left shows the bike path north of Norwalk Substation through the ROW with the adjacent areas mulched and restored. It is unclear whether this work is associated with 115kV contractors. Photo on the right shows the restored portion of Putnam Park storage area. 7/5/06

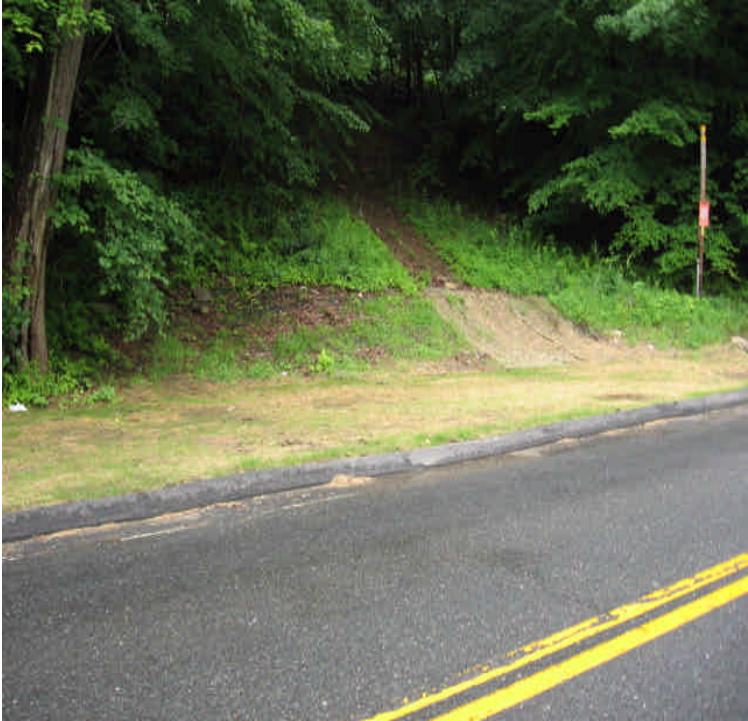
Photo on the left shows a view of some restoration, including erosion control mats placed on the slope across from Jacob's Lane. Photo on the right shows the graded and restored slope at the southern portion of the Bethel Ed. Park ROW. 7/5/06

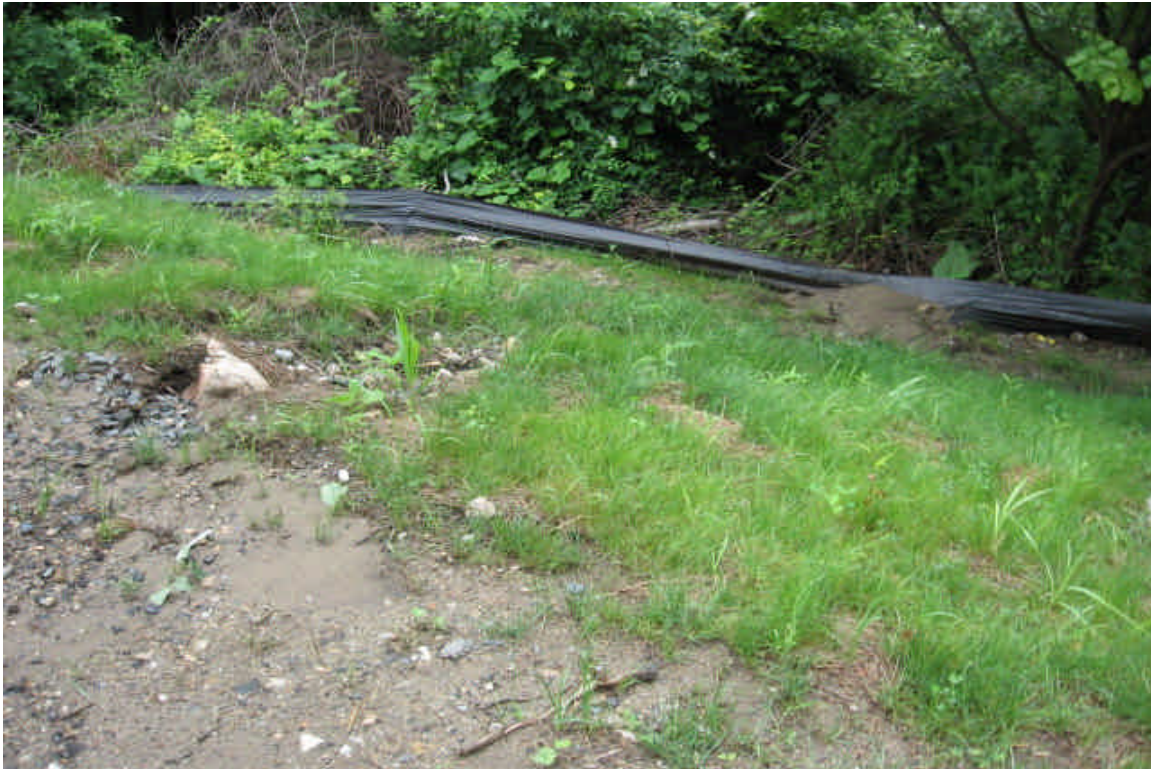
Photo on the left shows a view of the slope near the south tower. A washout was present here with sediment piling against the silt fence. Determine if erosion control mats are needed here or at the newly graded portion of the slope. 7/5/06

Areas of Inspection	Observation	Recommended Action	Corrective Action
Active Work	- Bethel Educational Park: - No additional work at this time. 7/5/06	-See EC section. 7/5/06	-N/A
Rt. 107, Redding	-Most roadside restoration appears complete. 7/5/06	- See EC section. 7/5/06	- N/A
Rt. 58, Bethel	-A few vehicles were noted parked in storage areas. 7/5/06	-See EC section. 7/5/06	- N/A
Broad Street/ROW, Norwalk	-The bike path is in place to Broad St. and adjacent areas were restored. 7/5/06	-Continue to monitor for stabilization. 7/5/06	-Adjacent areas were restored.
Main Ave. / Rt. 7, Norwalk	-Some internal vault work was planned. 7/5/06	-None at this time. 7/5/06	-N/A
Erosion and Sediment Controls	-The northern ROW remains in good shape 7/5/06	-Continue to monitor for stabilization. Grass is growing here. 7/5/06	-N/A
Bethel Education Park	- The slope had been graded and silt fence was well in place, however several washouts were noted due to the steep gradient just to the south of here. 6/28-7/5/06	- Investigate stabilization measures for this slope near the tower. Consider erosion control mats to prevent future washouts. 6/28-7/5/06	- Needs evaluation

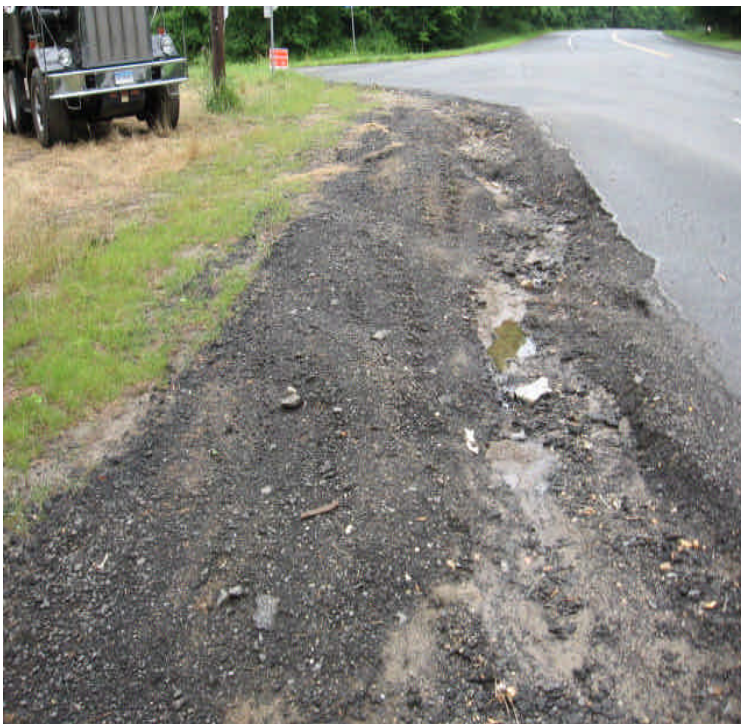
Both photos show the Sunset Hill storage area. Photo of the left shows the erosion from roadway run-off. Photo on the right shows where the washout continues to the silt fence. This fence is in good shape and prevents sedimentation to the wetland swale. 7/5/06
